Elevation QC Report

OR_RogueValley_2009 **Watershed Sciences Project:** Contractor: 04/20/2011 06/14/2011-06/15/2011 **Data Delivery Date: Date Data Reviewed: Kim Robinson** 2203.009 square miles **Total Square Miles Reviewed: Reviewer:** Tile size: 7.5' by 7.5' 3.00 intl feet **Grid Spacing: Elevation Type: LIDAR Format: LAS**

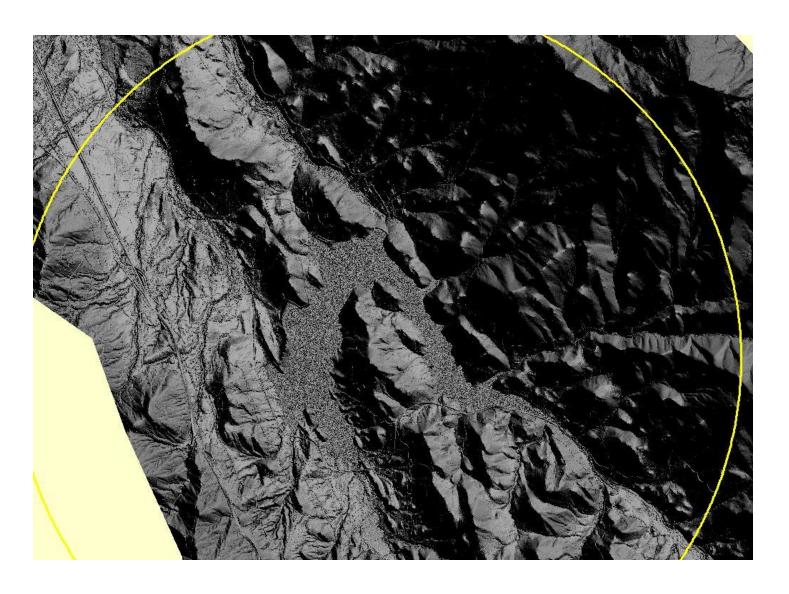
OLC-OR_ROGUEVALLEY_2009: Example of Water Body Not Flattened

There was no requirement for treatment of waterbodies or double line streams, therefore waterbodies are not flattened and double line streams have not been forced to drain downhill. Reviewer created a shapefile showing waterbodies that have not been flattened for reference purposes. An example will be provided below.

Based on the errors found, reviewer has asked that the data be re-examined.

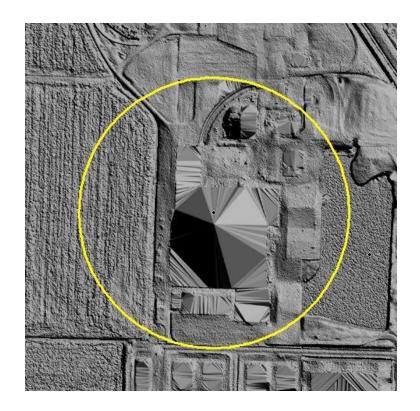
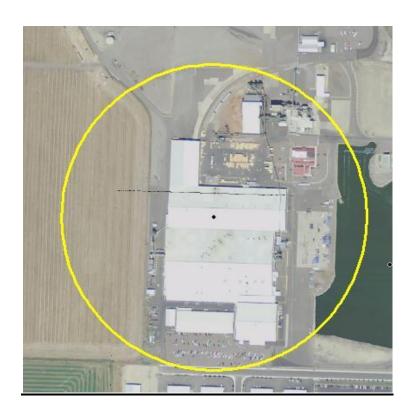
OLC-OR ROGUEVALLEY 2009: Example of Building Level Issue with NAIP Imagery in 3 D (same building as above example)

Reviewer noticed some other potential errors in the data. The first of these errors occur where buildings have been removed. Where most buildings removed, a flat "tinning" is observed, however, there are several cases where there were points above the surface and pits in an otherwise relatively flat surface. Reviewer created a shapefile at these areas. Examples will be shown below. The second error the reviewer noticed was excessive "tinning" across a road. This may be due to the removal of bare earth points that should be kept in this area. Reviewer included this in the shapefile of errors. A picture of this issue will be shown below.
